DEPARTMENT OF TRANSPORTATION

Contract #: 04-0120F4Cty: SF/ALA Rte: 80 PM: 13.2/13.9File #: 99.28**WELDING INSPECTION REPORT****Resident Engineer:**Pursell, Gary**Address:** 333 Burma Road**City:** Oakland, CA 94607**Report No:** WIR-012331**Date Inspected:** 27-Feb-2010**Project Name:** SAS Superstructure**OSM Arrival Time:** 645**Prime Contractor:** American Bridge/Fluor Enterprises, a JV**OSM Departure Time:** 1845**Contractor:** Zhenhua Port Machinery Company, Ltd (ZPMC) Chanxing Island**Location:** Shanghai, China**CWI Name:** N/A**CWI Present:** Yes No**Inspected CWI report:** Yes No N/A**Rod Oven in Use:** Yes No N/A**Electrode to specification:** Yes No N/A**Weld Procedures Followed:** Yes No N/A**Qualified Welders:** Yes No N/A**Verified Joint Fit-up:** Yes No N/A**Approved Drawings:** Yes No N/A**Approved WPS:** Yes No N/A**Delayed / Cancelled:** Yes No N/A**Bridge No:** 34-0006**Component:** OBG Segment 10BE**Summary of Items Observed:**

WELDING INSPECTION REPORT

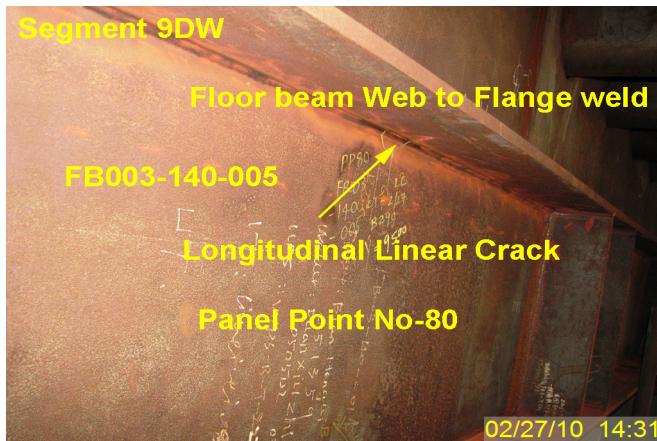
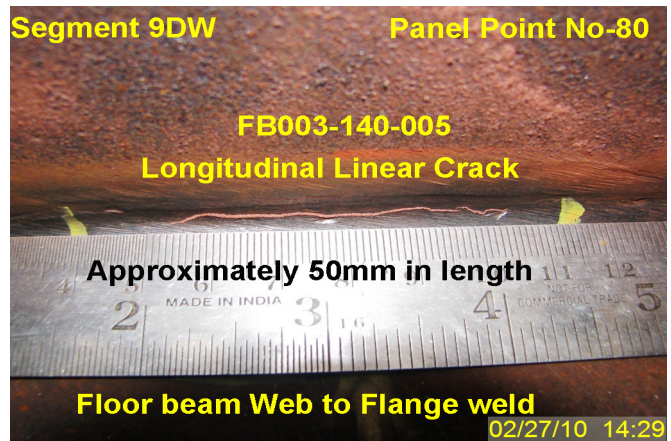
Description of Incident: During random Quality Assurance Visual review of welds located on segment 9DW, this Quality Assurance Inspector (QA) discovered one longitudinal linear crack measuring approximately 50mm in lengths. The indications were discovered visually and confirmed by Magnetic particle Testing (MT) by Caltrans QA. ZPMC Quality Control MT Technicians claimed that magnetic particle testing have been performed on these welds that require 25% MT. The indication is clearly marked on the material near the weld. The welds are identified as FB003-140-005. The panel point is identified as a PP80. This weld is a Fillet weld joining the Floor beam Web to Flange. The Floor Beam Flange weld is identified as Non SPCM. For further information, please see the attached pictures
